ALABAMA DEPARTMENT OF TRANSPORTATION

Annual Inspection Report

Butler-Choctaw County Municipal Airport

ANNUAL INSPECTION REPORT

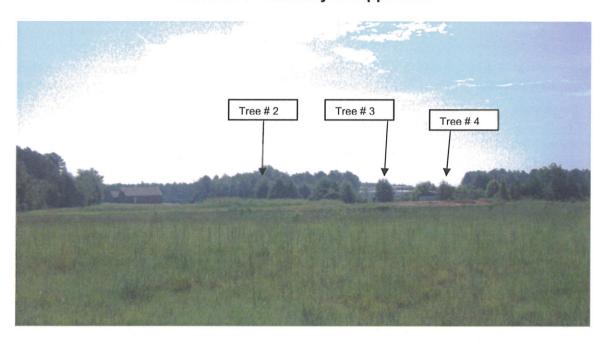
Runway 29: A Tree identified as Tree # 4 violates the 20:1 approach/departure path. Also, although not penetrating the 20:1 approach/departure path trees identified as Tree # 2 and Tree # 3, if allowed to continue growing, will eventually become a violation (See Photo # 1 and # 2 and Appendix 2).

All obstructions must be removed and it is suggested that the potential obstructions be removed before they become a safety hazard.

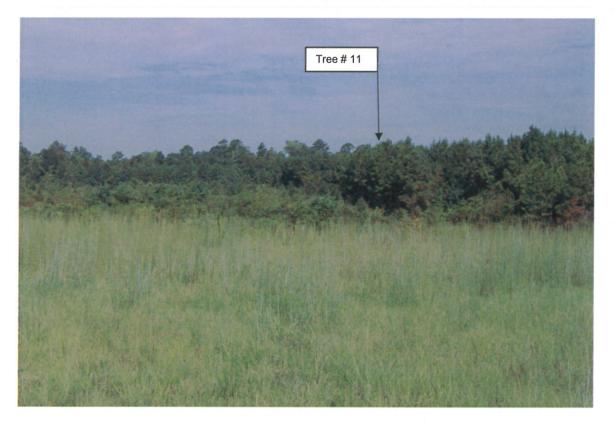
• Runway 11: From the displaced threshold, a tree identified as Tree # 11 violates the 20:1 approach/departure path (See Photo # 3).

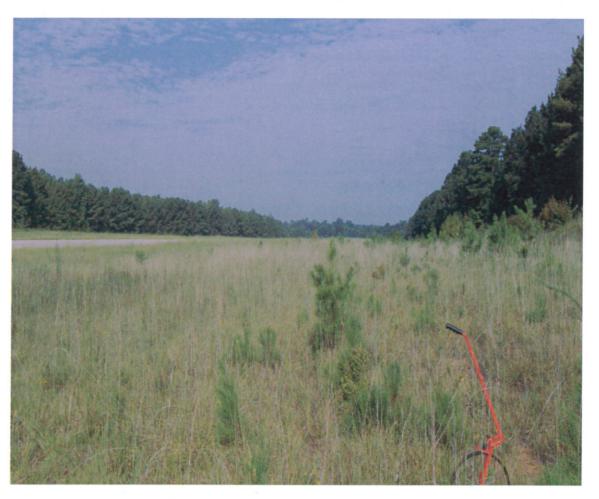
There are small pines and brush growing within the primary surface (See Photo # 4).

The runway markings are in poor condition (See Photo # 4).

• All natural obstructions must be removed and primary surface should be kept in a mowable condition.

Markings should be replaced in accordance with FAA AC 150/5340-1J.

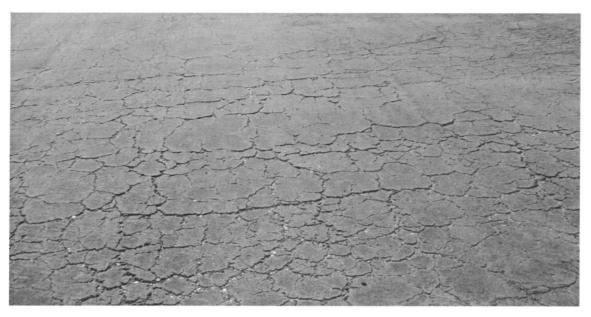
• The airport pavement surfaces are in fair condition. There was some evidence of joint cracks with vegetation on the runway and small block and alligator cracking on the apron (See Photo 5).

It is recommended that a pavement maintenance project be conducted to ensure the maximum useful life of the airport pavement. Removing vegetation from the pavement, crack cleaning and sealing and a surface treatment should be performed.
